**[Docket No. FAA–2017–0288; Product Identifier 2017–CE–007–AD; Amendment 39–19231; AD 2018–06–11]**

#### Airworthiness Directives; Textron Aviation Inc. Airplanes

**ACTION:** Final rule.

##### 2018-06-11 Textron Aviation Inc.:

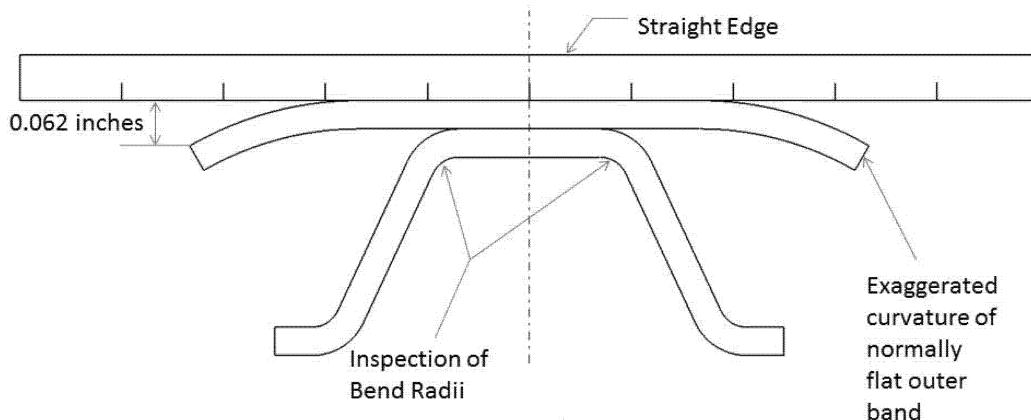
Figure 1 to paragraphs (k)(1)(iii) and (v) of this AD: Cross section of v-band coupling

(iii) Visually inspect the flatness of the outer band using a straight edge. Lay the straight edge across the width of the outer band. The gap must be less than 0.062 inches. See figure 1 to paragraphs (k)(1)(iii) and (v) of this AD. If the gap exceeds 0.062 inches between the outer band and the straight edge, do not re-install the v-band coupling. Before further flight, you must install a new v-band coupling and restart the hours TIS for the repetitive replacement of the v-band coupling.

(v) Visually inspect the bend radii of the coupling v-retainer coupling segments for cracks. Inspect the radii throughout the length of the segment. See figure 1 to paragraphs (k)(1)(iii) and (v) of this AD. If any cracks are found, do not re-install the v-band coupling. Before further flight, you must install a new v-band coupling and restart the hours TIS for the repetitive replacement of the v-band coupling.
