**Turbocharged, Reciprocating Engine Powered Aircraft**

**Exhaust System  
Turbocharger to Tailpipe  
V-band Coupling / Clamp Working Group**

**Final Report**

**January 2018**

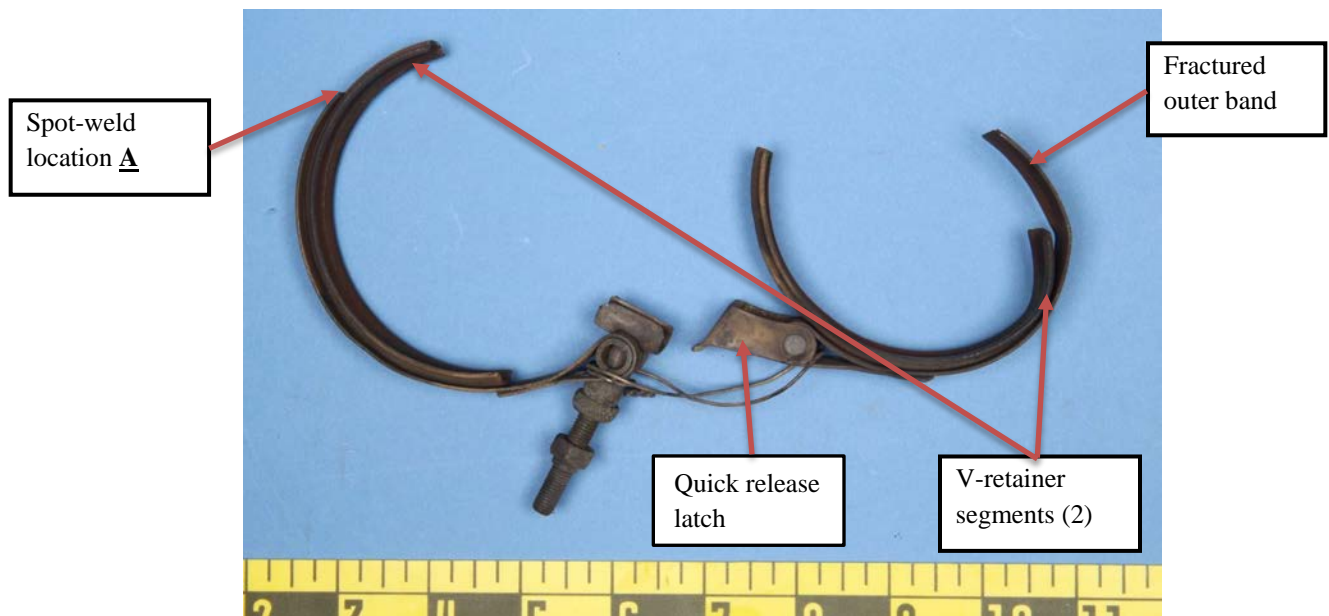
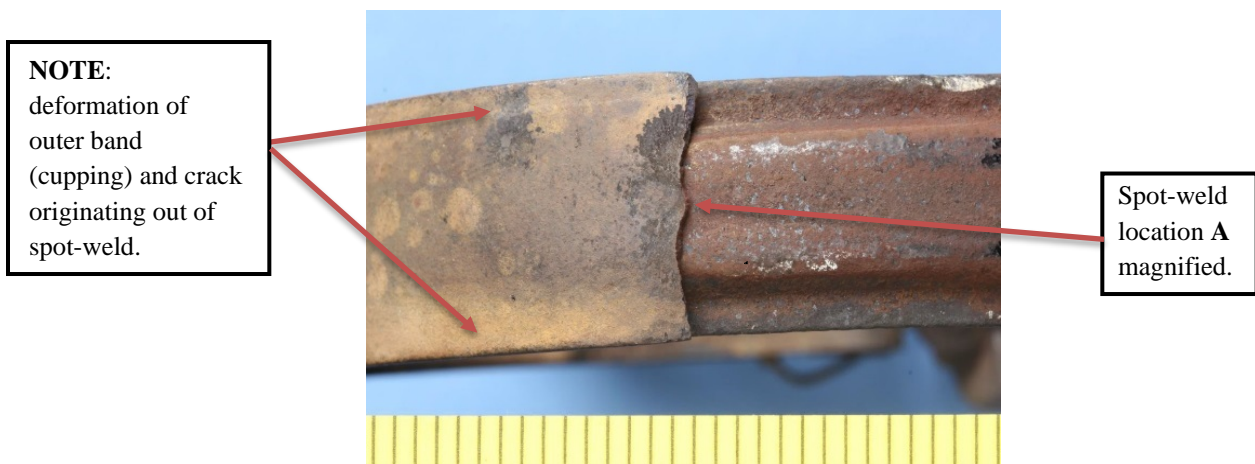
**Spot-welded, 2-segment Coupling with Quick Release latch**

The above failure started as a crack that originated out of the spot-weld. The crack grew to a full transverse outer band crack that caused separation of the coupling. The above failure resulted in loss of the tailpipe, smoke in the cockpit, in-flight fire and fatalities. Note the safety wire is still in place.

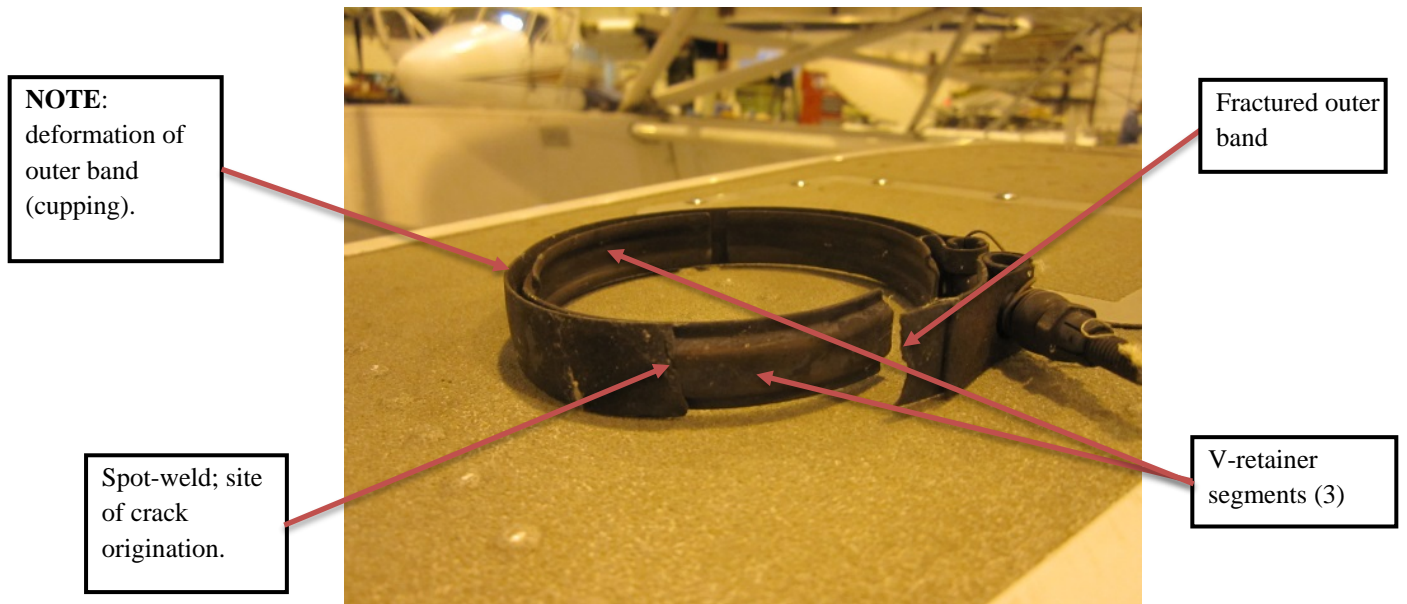
**Figure 10**  
**Spot-welded, 3-segment Coupling**

The above failure started as a crack that originated out of the spot-weld. The crack grew to a full transverse outer band crack that caused separation of the coupling. The above failure resulted in loss of the tailpipe, smoke in the cockpit, in-flight fire and a very quick, direct in approach and landing on fire. There were no fatalities. Note again the safety wire is still in place.

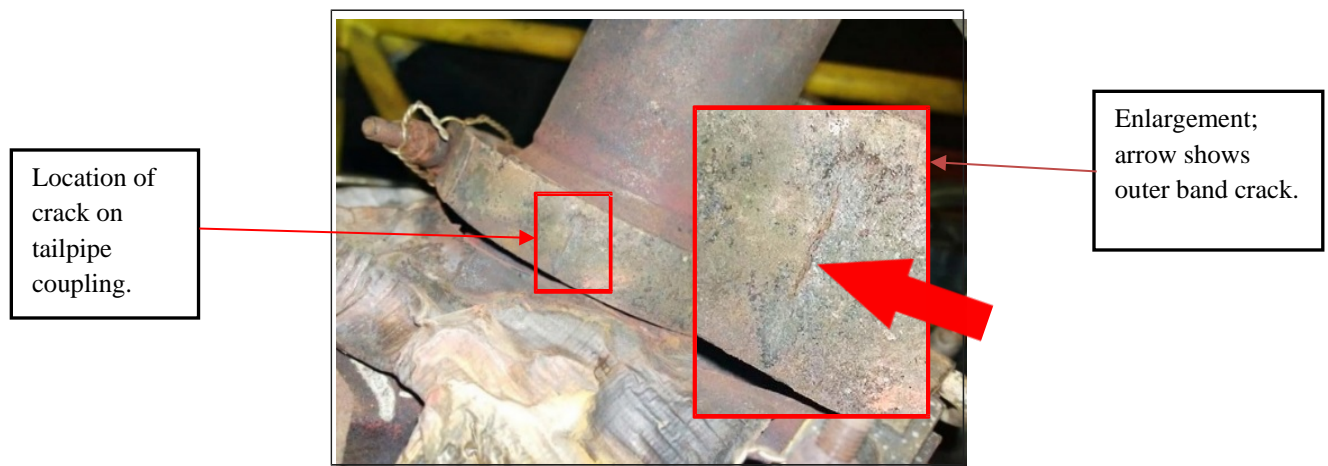
**Figure 11**  
**Spot-welded, Multi-segment Coupling**

The above crack originated at a spot-weld. However, the crack had not grown across the outer band and the coupling had not separated yet. Found on inspection for another issue.

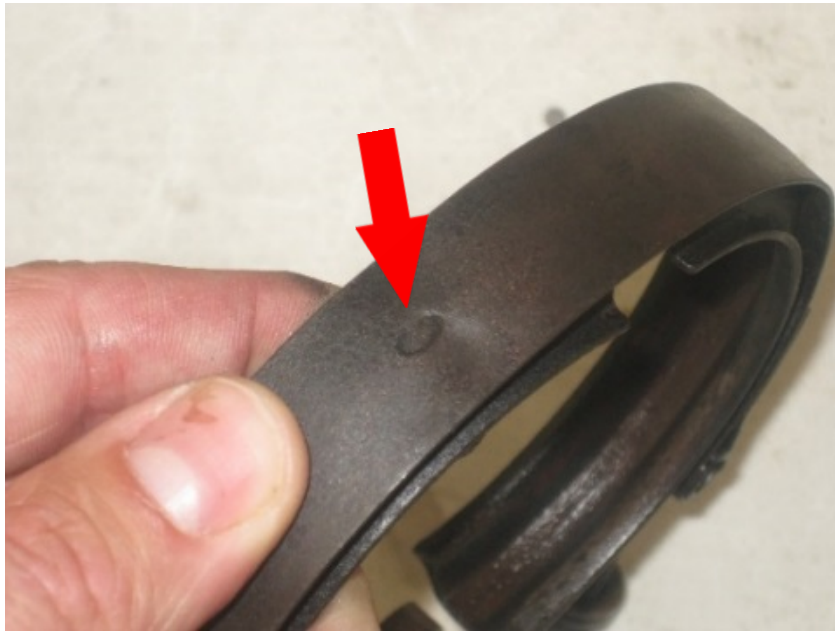
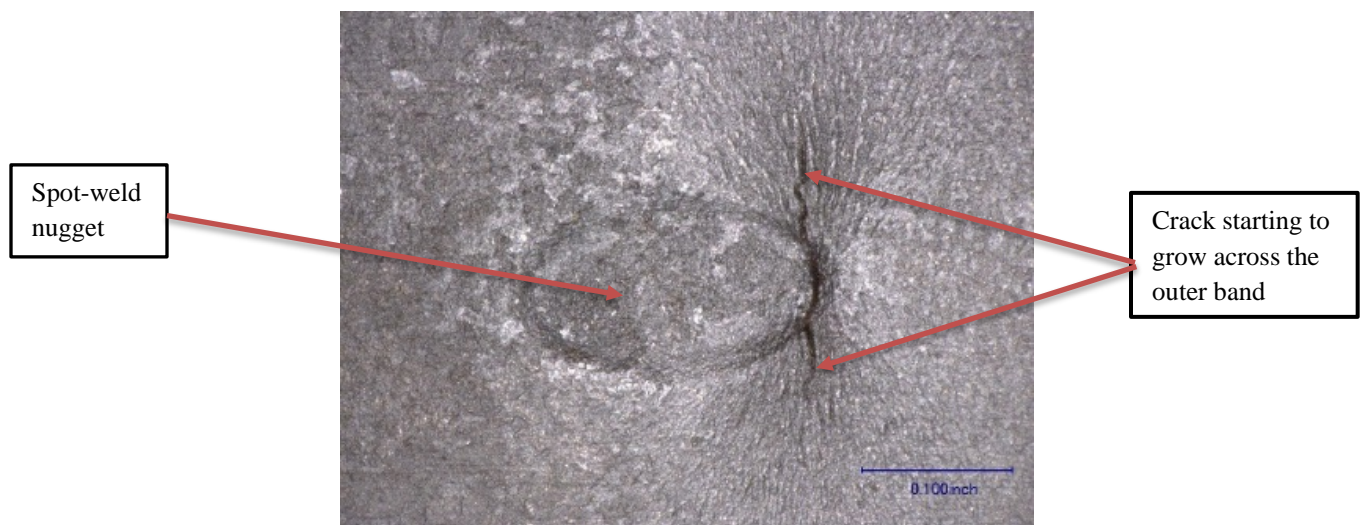
**Figure 12**  
**Spot-welded, 3-segment Coupling**

The red arrow shows where the coupling is deformed at a spot-weld where the crack originates. The crack had not yet grown across the outer band and the coupling had not separated. Found on inspection for another issue.

**Figure 13**  
**Same coupling above magnified**

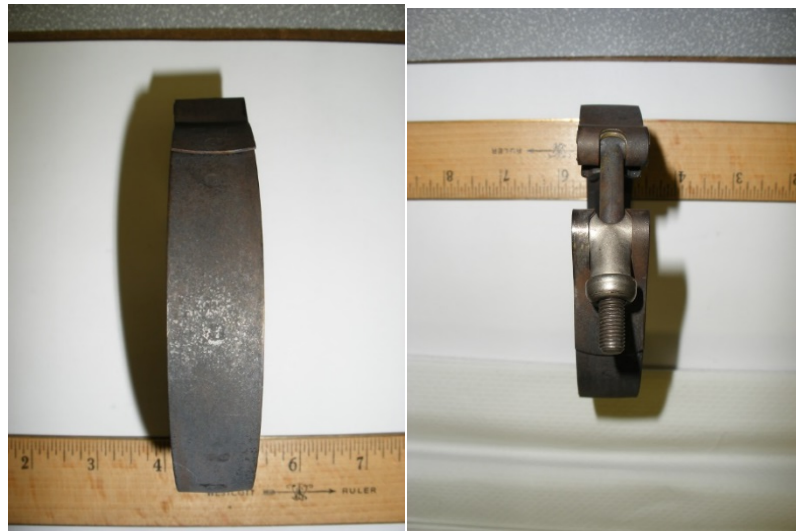
**Figure 14**  
**Spot-welded, 3-segment Coupling**

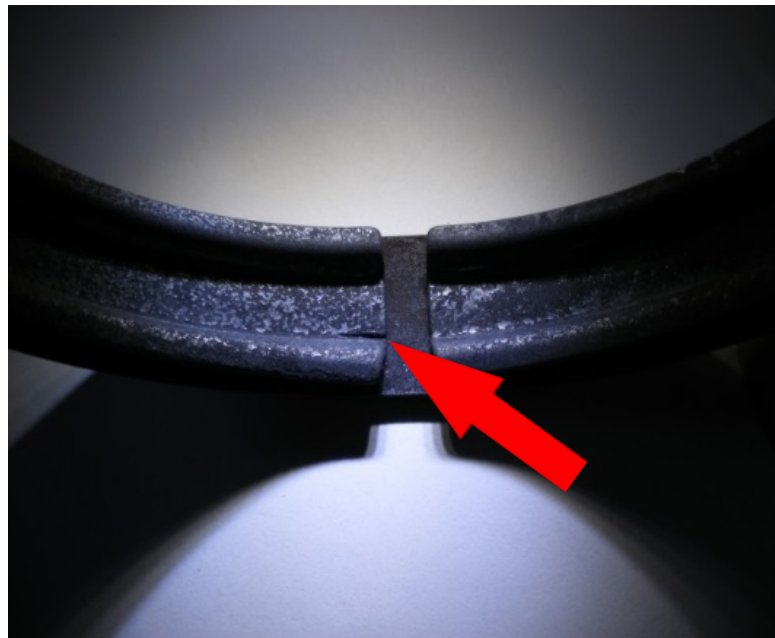
**Figure 15**  
**Spot-welded, 3-segment Coupling**

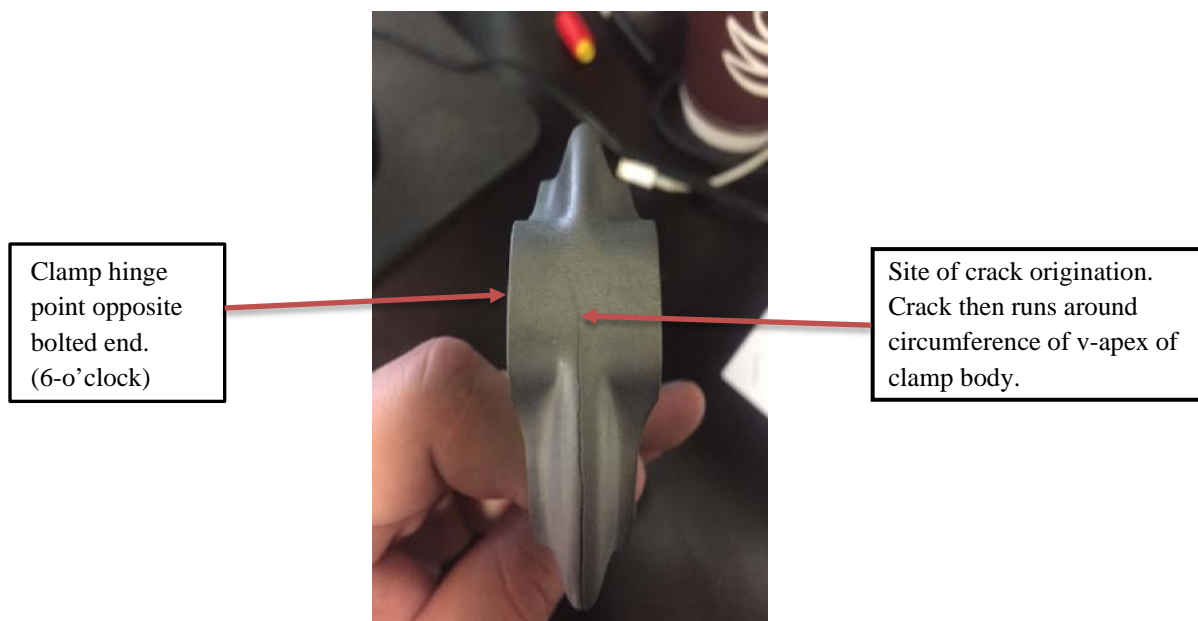
**Figure 16**  
**Single-Piece Clamp**

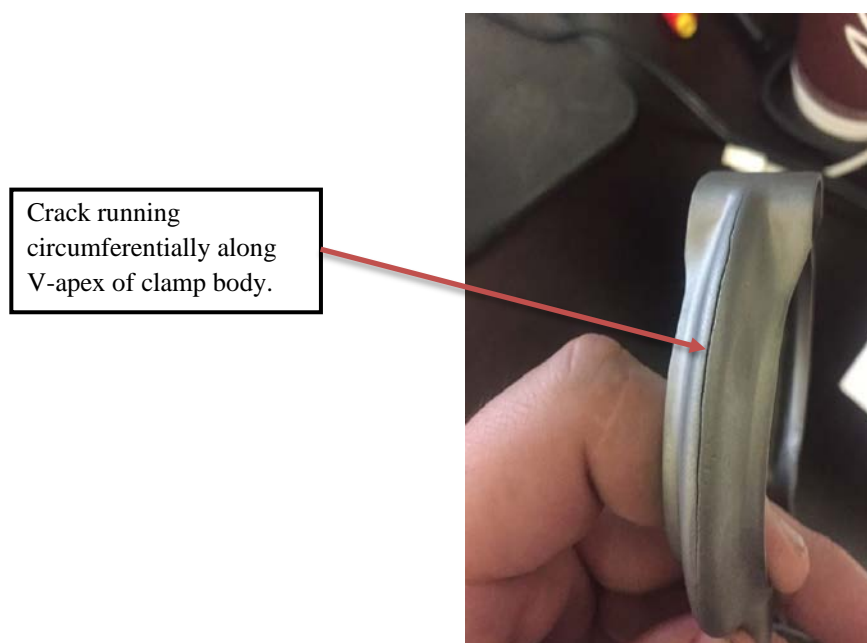
**Figure 17**  
**Single-Piece Clamp**

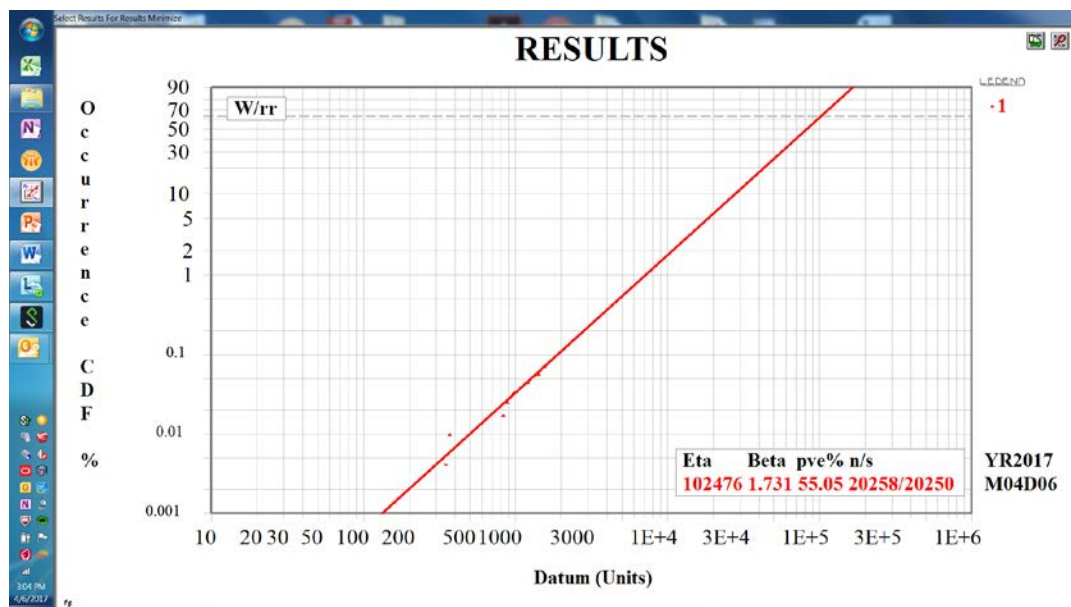
### Multi-segment coupling Weibull

The Weibull analysis indicates a wear out failure mode ( $\text{Beta} > 1$ ) for multi-segment couplings.

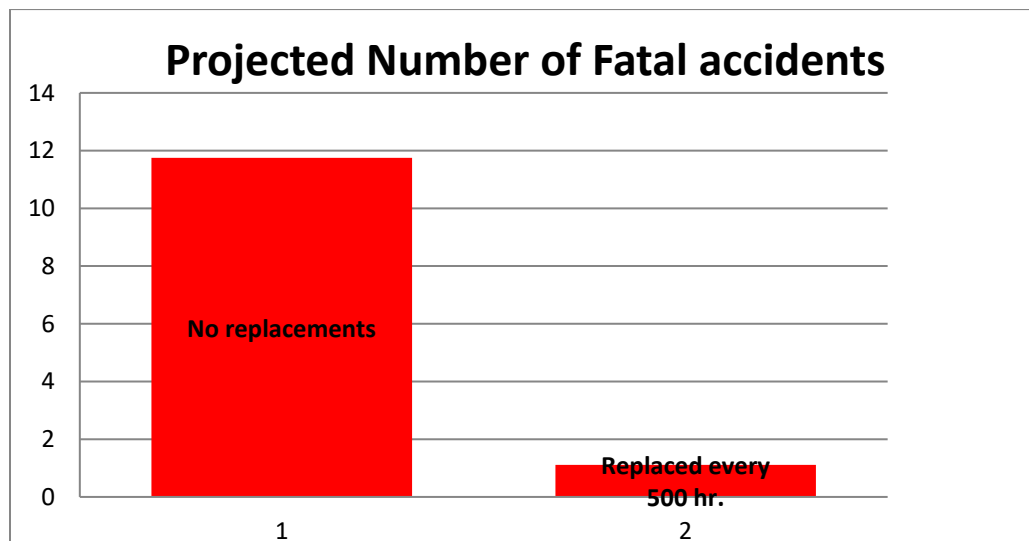
### Multi-segment coupling fleet risk- Projected number of fatal accident over the next 20 years Uncorrected vs. Corrected

Multi-segment coupling failures have resulted in 6 fatal accidents. Data indicates multi-segment coupling replacements at 500 hrs. time in service (TIS) (e.g., life limit) combined with a fleet wide initial 50 hr. TIS replacement campaign, and an ongoing annual inspection reduces the individual risk below SARA guidelines for mandatory action, and the fleet risk is reduced to an acceptable level.

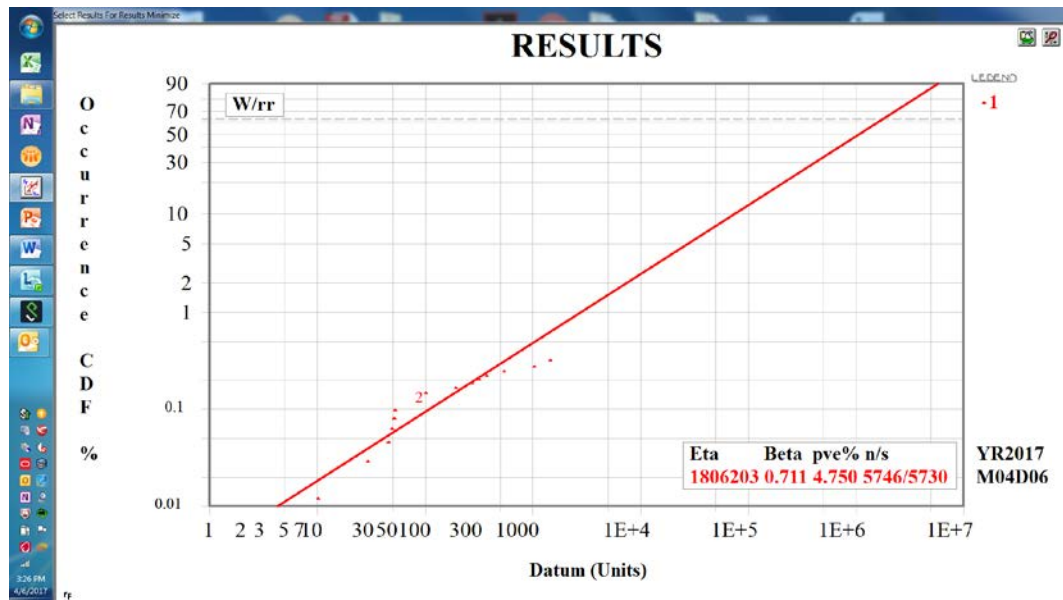
### Single-piece V-band clamp Weibull

The Weibull plot above signified overall infant mortality ( $\text{Beta} < 1$ ) for single-piece clamps. The lower quality Weibull indicated the possibility of mixed failure modes. A review of failure reports showed some early failures likely due to installation technique, along with other traditional wear out failures. Field reports indicated that the single-piece clamp cracks are easier to find on inspection, and in most cases replaced before complete failure.

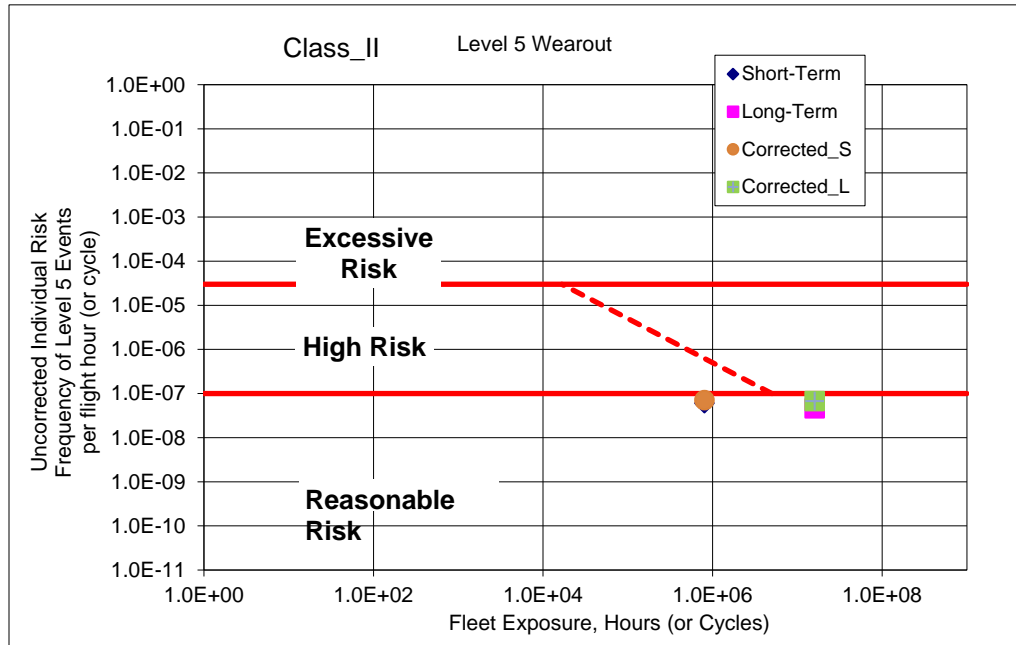
**Single-piece clamp individual risk for Class II airplanes-  
Projected frequency of fatal accidents  
No replacements (uncorrected) vs. 2,000-hour replacements (corrected)**

With all factors considered, data indicated that single-piece clamp replacements before 2,000 hrs. (assumed approximate time for engine overhaul) may not be beneficial. However, replacement of single-piece clamps at approximate overhaul time, plus well defined periodic (annual) inspections, along with improved installation instructions and training may control risk to an acceptable level. Without other interventions such as annual inspections and additional training, risk associated with infant mortality failure modes usually increases with scheduled replacements.

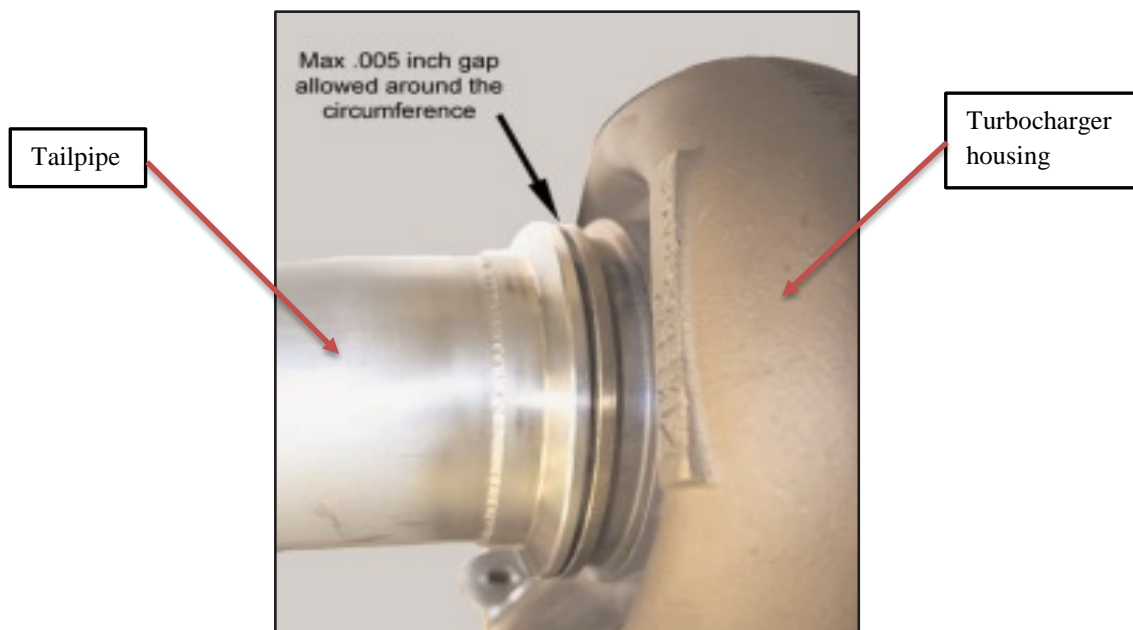
**Figure 9**

Inspect the turbocharger exhaust exit flange and the exhaust tailpipe flange interfaces for any un-flat (0.005 in. or greater) or wavy condition, corrosion, pitting, scaling or deposits (not easily removed) and correct per the manufacturer's recommendations. Refer to Figure 9.

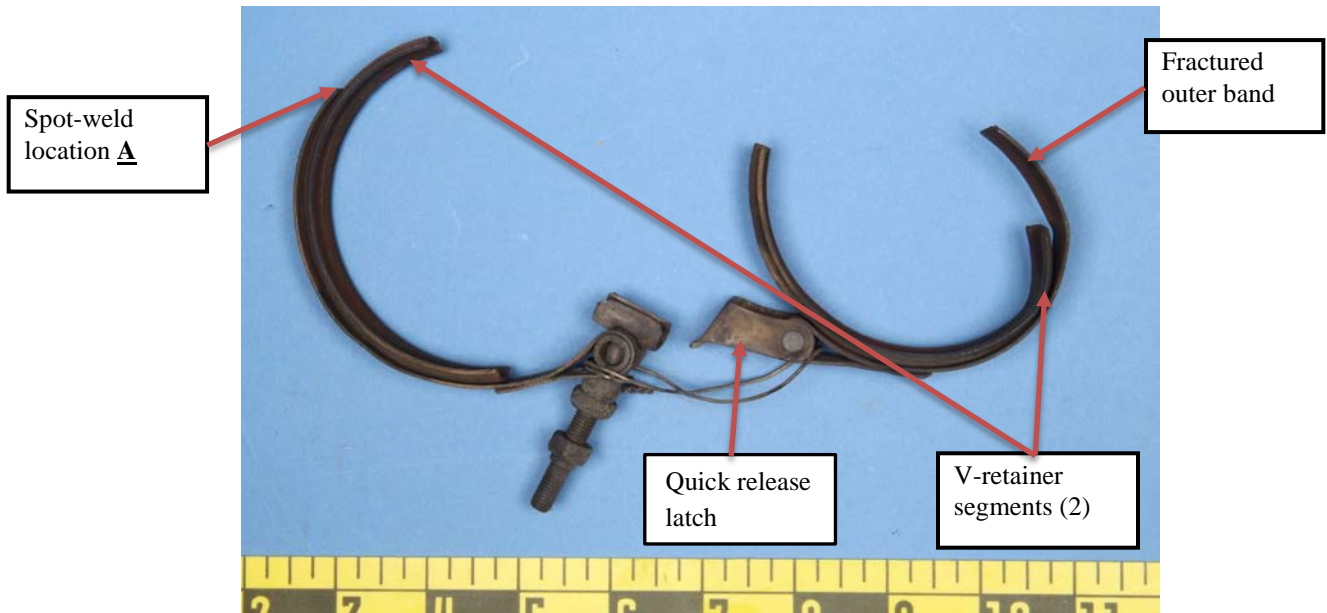
**Spot-welded, 2-segment Coupling with Quick Release Latch**

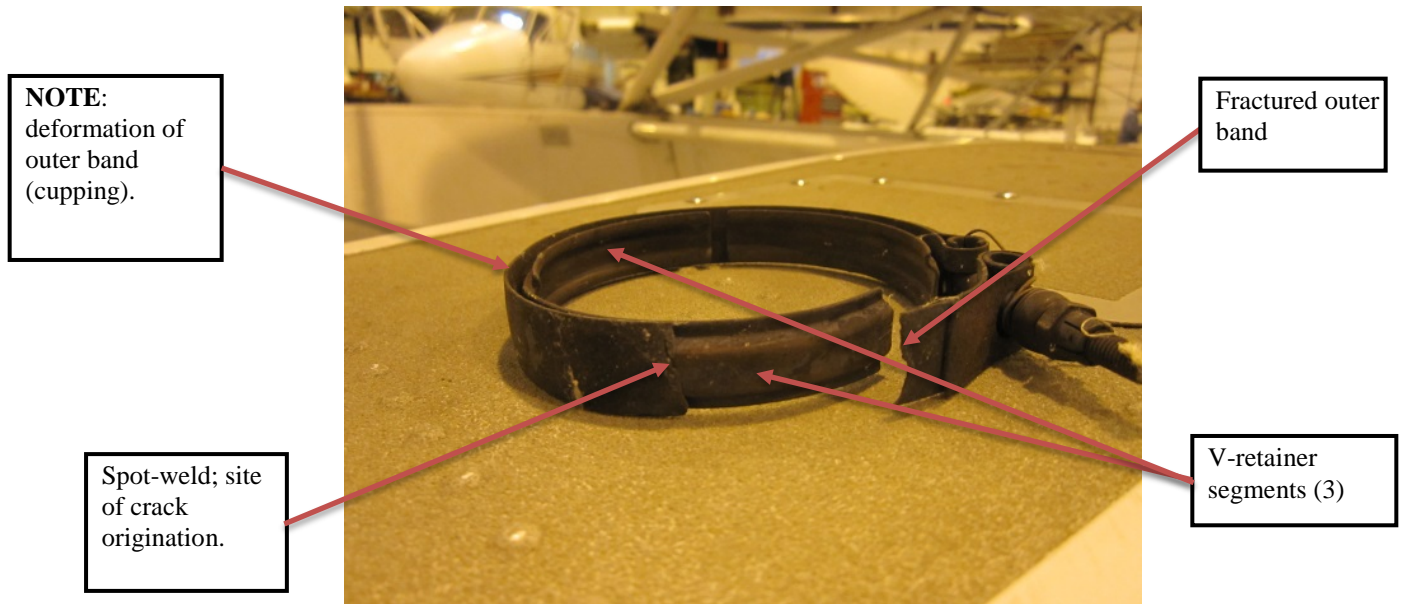
**Figure 20**  
**Spot-welded, 3-segment Coupling**

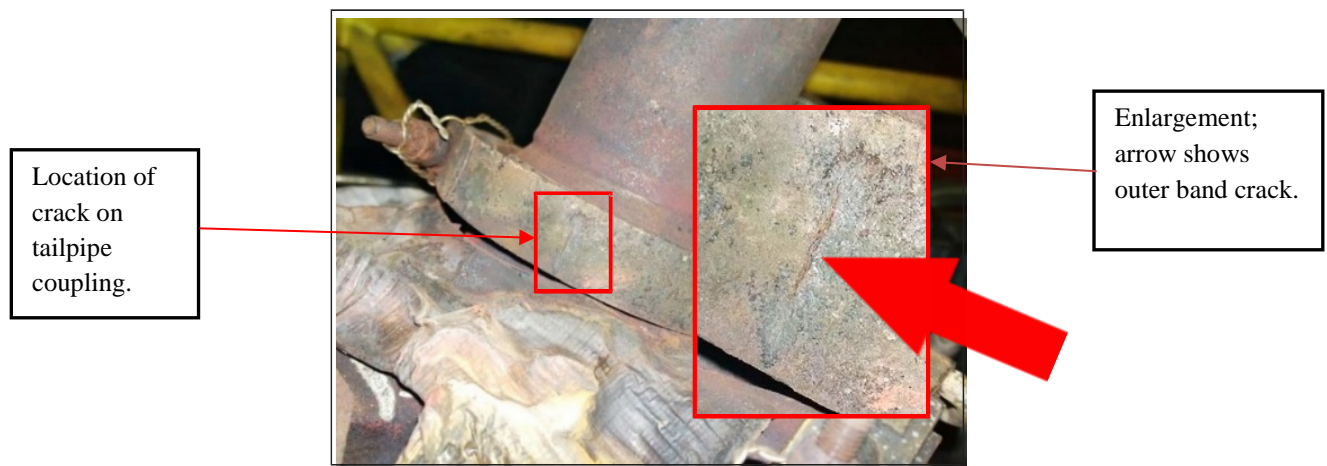
**Figure 21**  
**Spot-welded, Multi-segment Coupling**

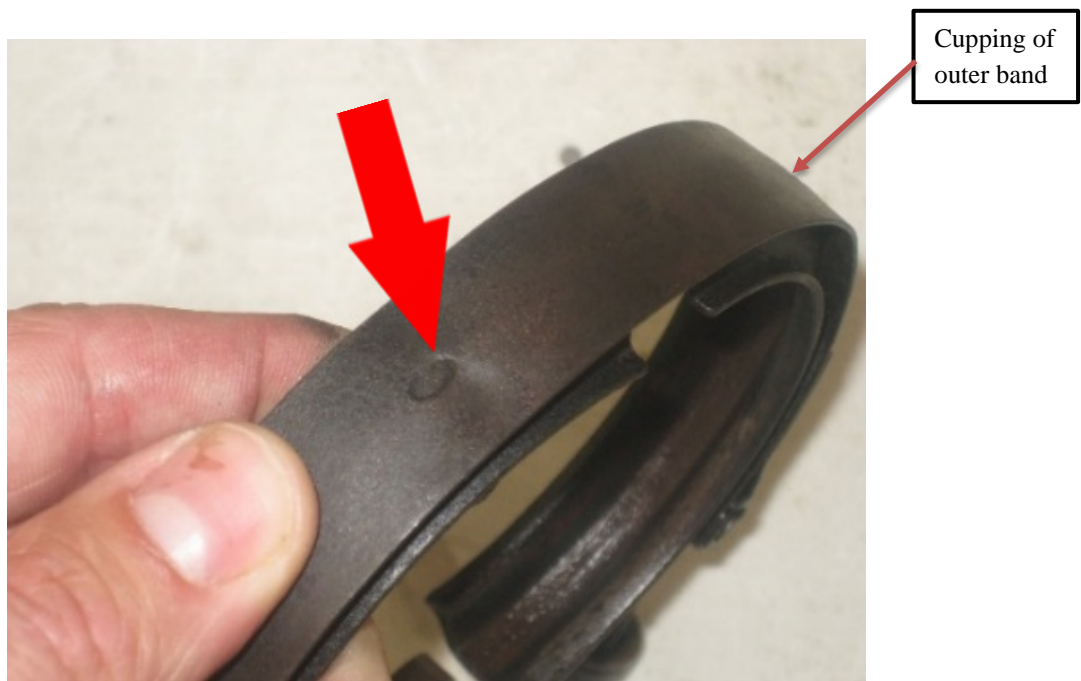
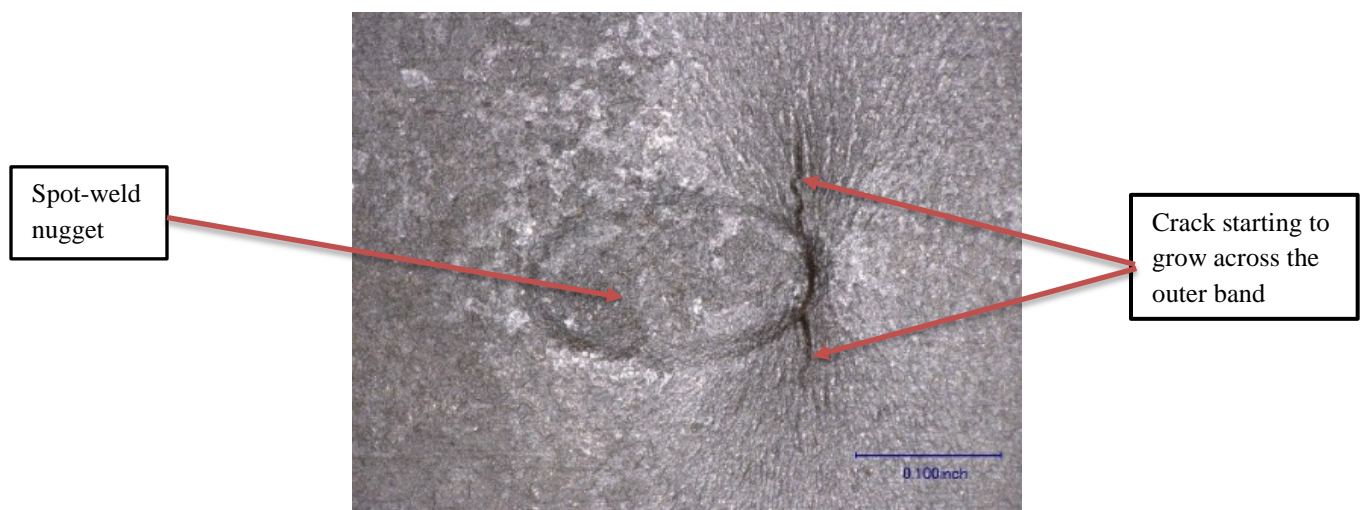
**Figure 22**  
**Spot-welded, 3-segment Coupling**

**Figure 23**  
**Same coupling above magnified**

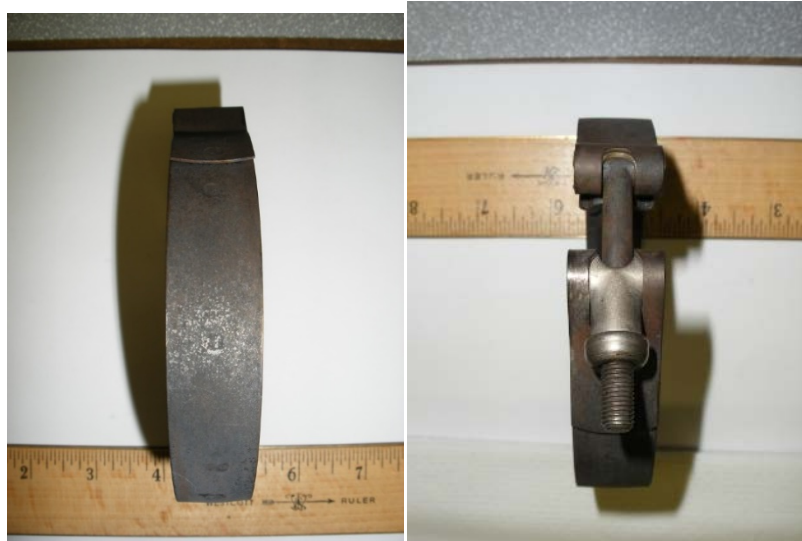
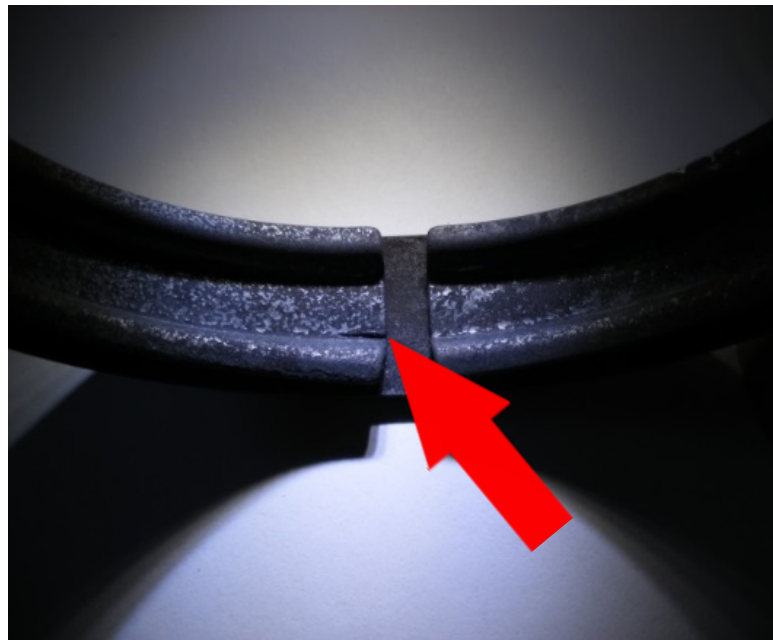
**Figure 24**  
**Spot-welded, 3-segment, Coupling**

**Figure 25**  
**Same coupling above magnified**

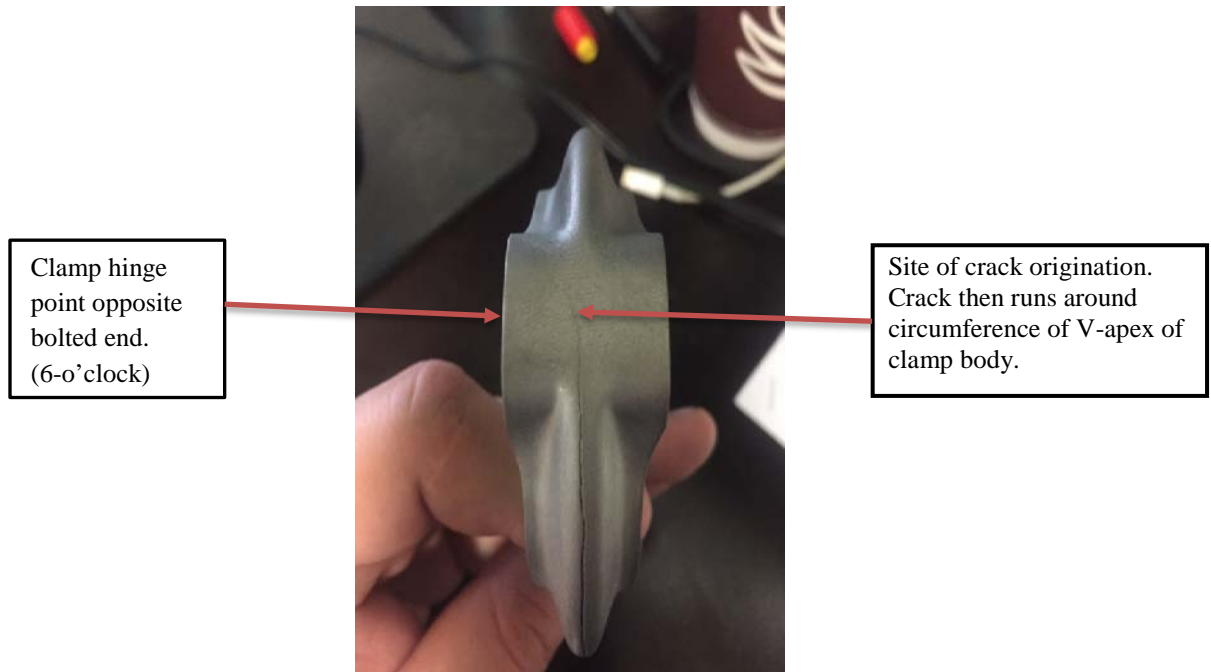
**Figure 26**  
**Single-Piece Clamp**

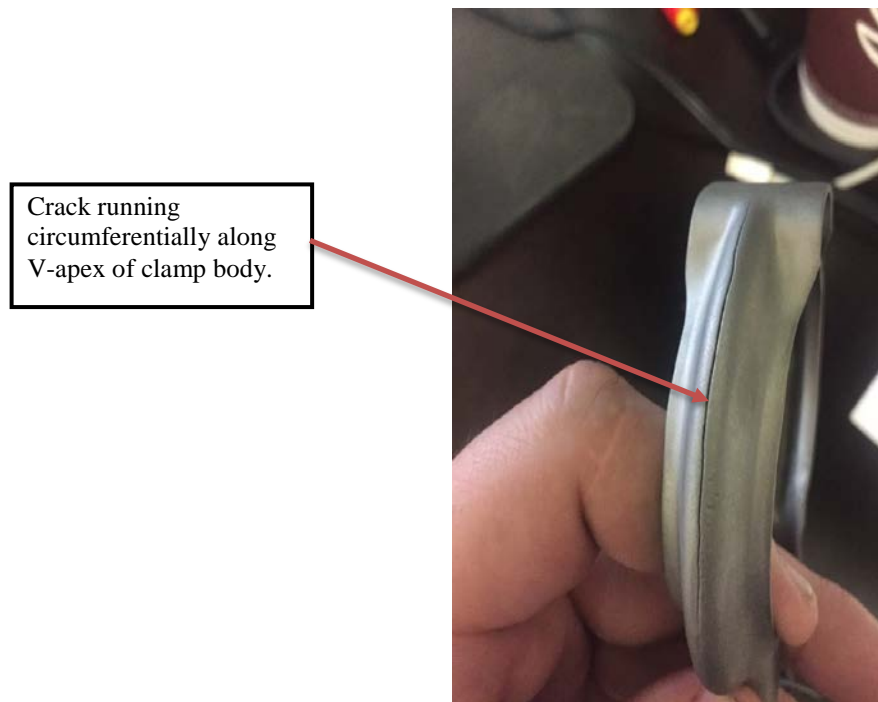
**Figure 27**  
**Single-Piece Clamp**
