FAA Clamps Down on V-Band Failures

To educate the maintenance community about powerplant and component failures — the third ranking cause of fatal general aviation accidents — *FAA Safety Briefing* is addressing maintenance safety enhancements recommended by the General Aviation Joint Steering Committee (GAJSC). This issue’s topic will focus on V-band coupling/clamp failures.

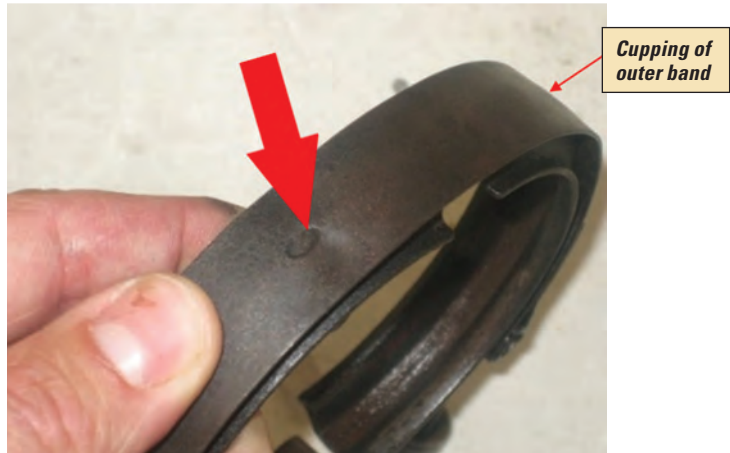
Spot-welded, 3-segment Coupling — The red arrow shows where the coupling is deformed at a spot-weld where the crack originated. The crack had not yet grown across the outer band and the coupling had not separated. Found on inspection for another issue.

REQUIREMENT	SPOT-WELD V-BAND COUPLING	RIVETTED V-BAND COUPLING	SINGLE-PIECE CLAMP
Visual Inspection	Annually	Annually	Annually
Life-Limit	500 hours total time in-service with no life extensions	2000 hours total time in-service with no life extensions	2000 hours total time in-service with no life extensions
