**Turbocharged, Reciprocating Engine Powered Aircraft**

**Exhaust System  
Turbocharger to Tailpipe  
V-band Coupling / Clamp Working Group**

**Final Report**

**January 2018**

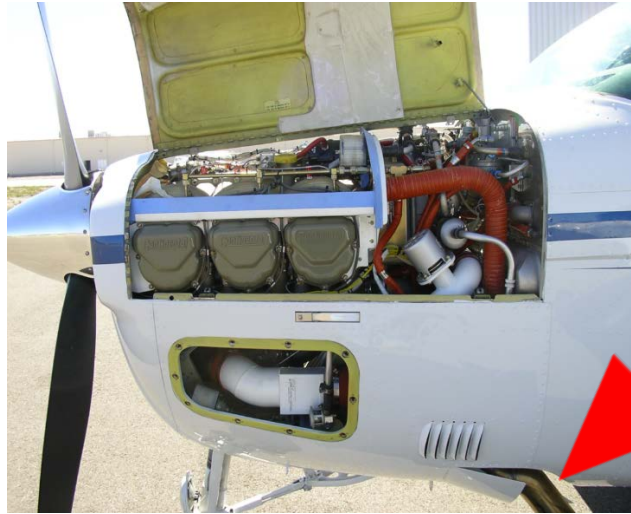
Below is a single engine airplane with engine cylinder exhaust ports located at the bottom of each cylinder. The upper cowl is open and a lower access panel is removed. As you can see the turbocharger in this application is not readily visible nor is the V-band coupling/clamp. The Design Approval Holder (DAH) also incorporated heat protection features in their type design to prevent exhaust heat from impinging on the surrounding area. The heat protection features typically include a set of sheet metal heat shields or fireproof foil type insulation in the form of a blanket or a combination thereof. The heat protection features that are a necessity also work well to obscure visibility of the turbocharger, and V-band coupling/clamps. The large red arrow denotes the tailpipe.

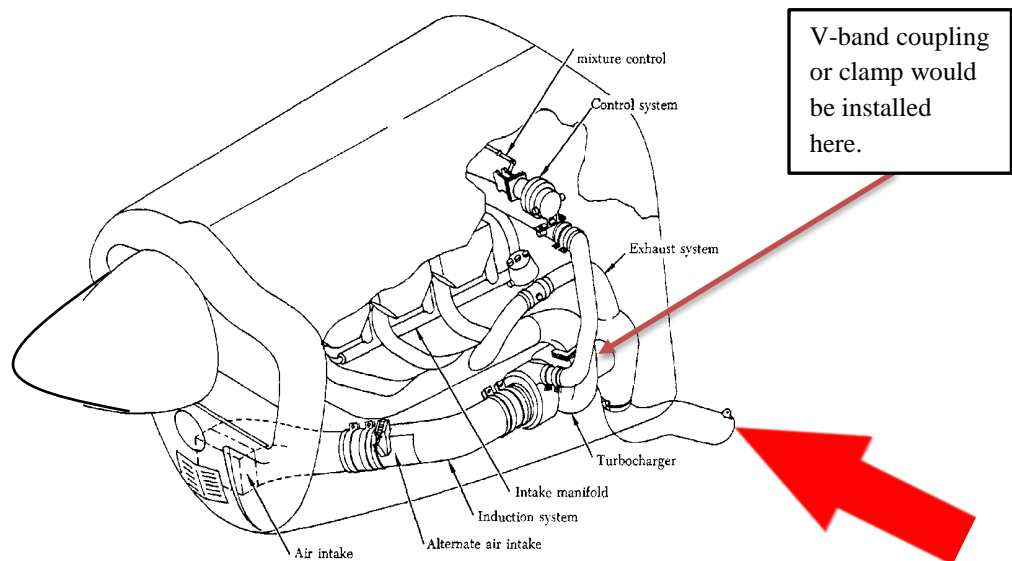
The diagram below depicts the turbocharger installation for the airplane above and the LH-side of the exhaust system. Notice none of the type design required heat protection features are shown installed. This is a typical retractable landing gear, single turbocharged engine airplane. The large red arrow denotes the tailpipe. The other arrow points to where the V-band coupling/clamp should be found. The V-band coupling/clamp in this application would not be readily visible during a pre-flight type inspection.

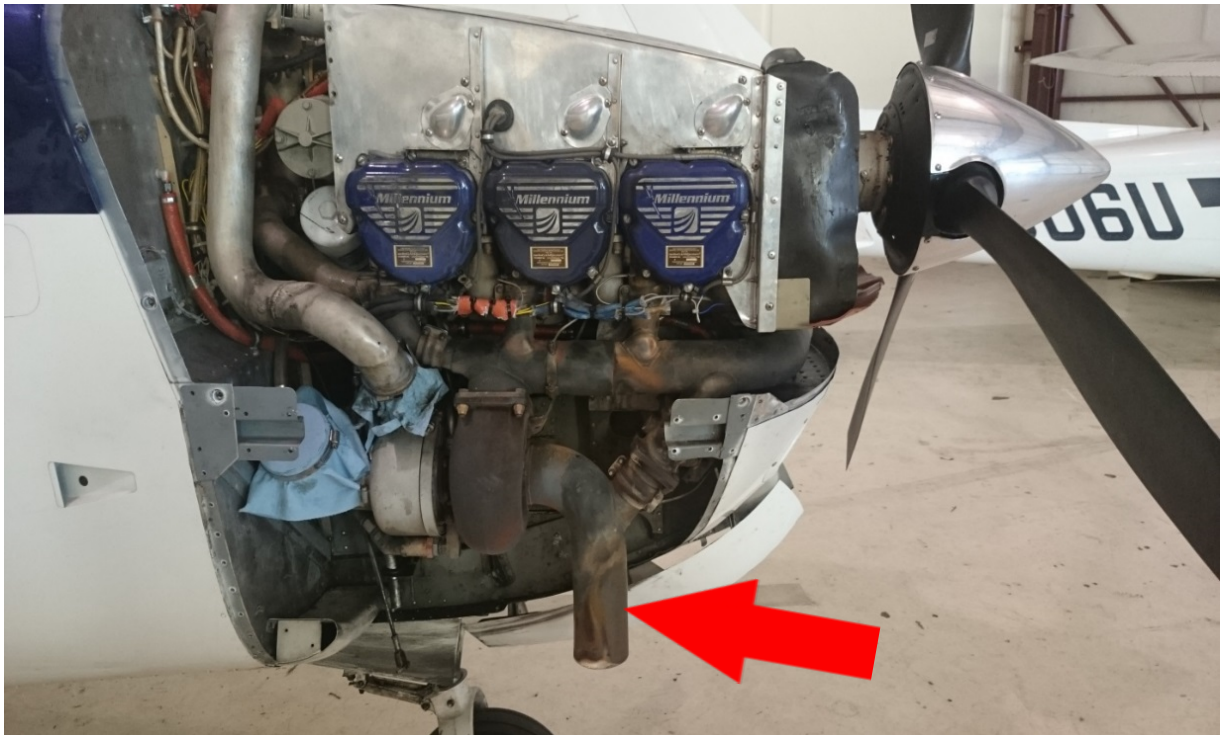
Another turbocharged single engine airplane, with engine cylinders with bottom exhaust ports is depicted below. The cowling has been removed. You can't see the turbocharger clearly with the lower cowling installed. The large red arrow denotes the tailpipe which is connected directly to the turbocharger exhaust exit flange just up and aft on the tailpipe. The tailpipe V-band coupling/clamp is not visible below. As you can see by the installation, the turbocharger in this application is not readily visible without a significant amount of maintenance activity, nor is the V-band coupling/clamp. In other words, this coupling /clamp installation would also not be readily accessible for pre-flight inspection.

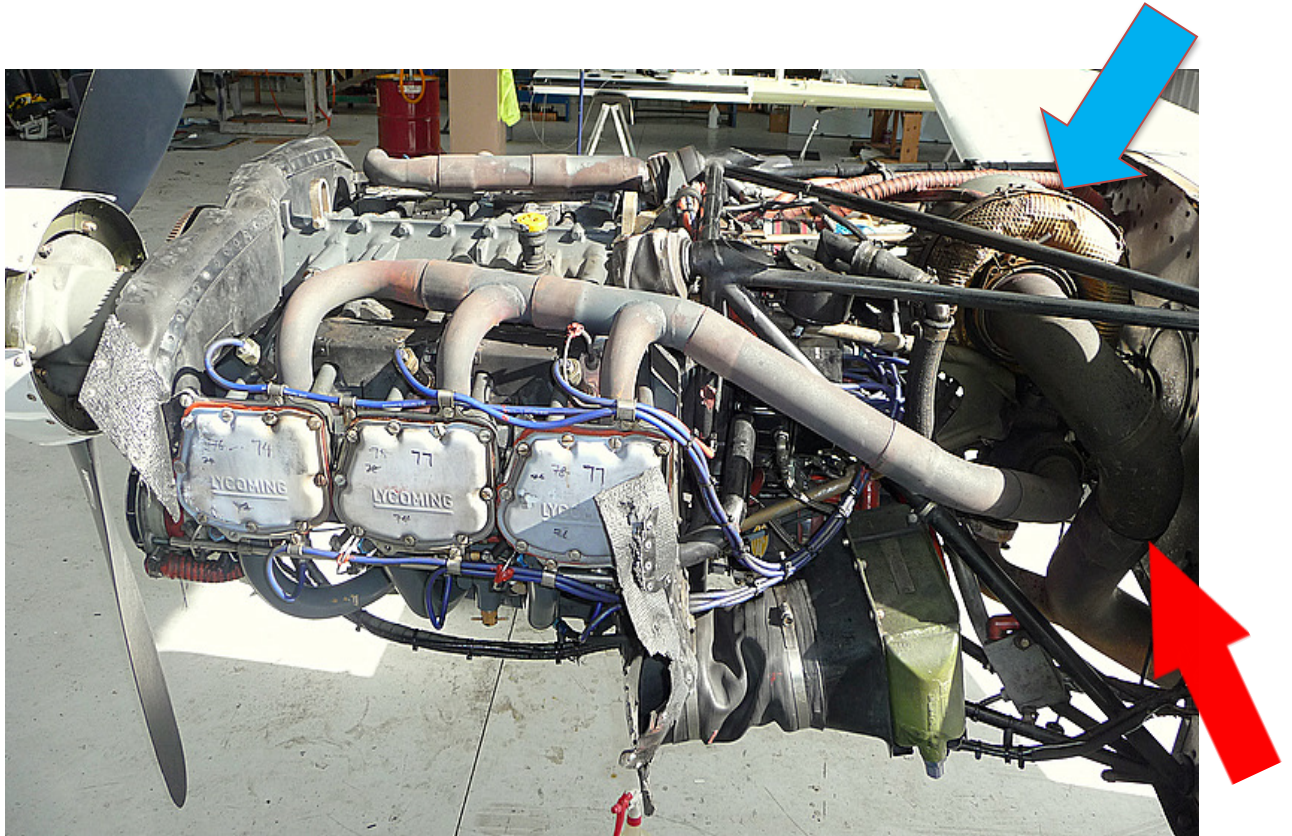
Below is a twin turbocharged engine airplane with an engine with top exhaust ports. The lower red arrow denotes the large tailpipe, and the circular housing just inboard of the tailpipe is the turbocharger which in this application is under a heat insulation blanket. The upper blue arrow points to the threaded end of the T-bolt of the multi-segment V-band coupling attaching the tailpipe to the turbocharger. On this type of turbocharger installation, you may see more of the turbocharger and heat protection features when the cowling is removed for an annual/100-hr. inspection. However, even then one would be hard pressed to find a crack anywhere along the multi-segment, V-band coupling, V-retainer inner surface when installed.

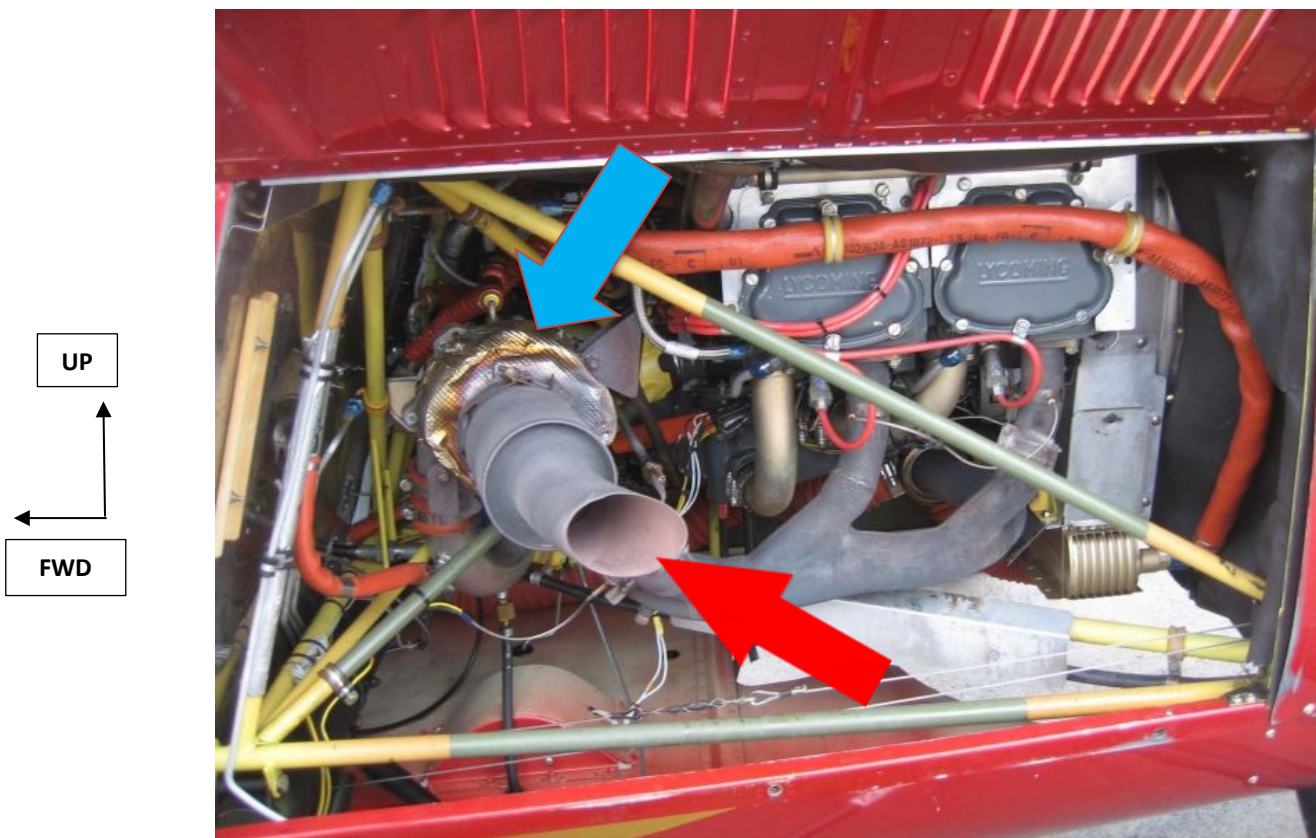
And finally, depicted below is a turbocharged engine used in a rotorcraft application with a LH forward turbocharger installation. The engine has cylinders with bottom exhaust ports. The hinged upper cowling door is open. The lower red arrow denotes the tailpipe/muffler assembly which is connected directly to the turbocharger exhaust exit flange just inboard of the muffler body on the tailpipe. The upper blue arrow points to the tailpipe multi-segment, V-band coupling just in front of the turbocharger heat insulation blanket. This type of installation may allow a very good pre-flight inspection of the tailpipe and coupling.

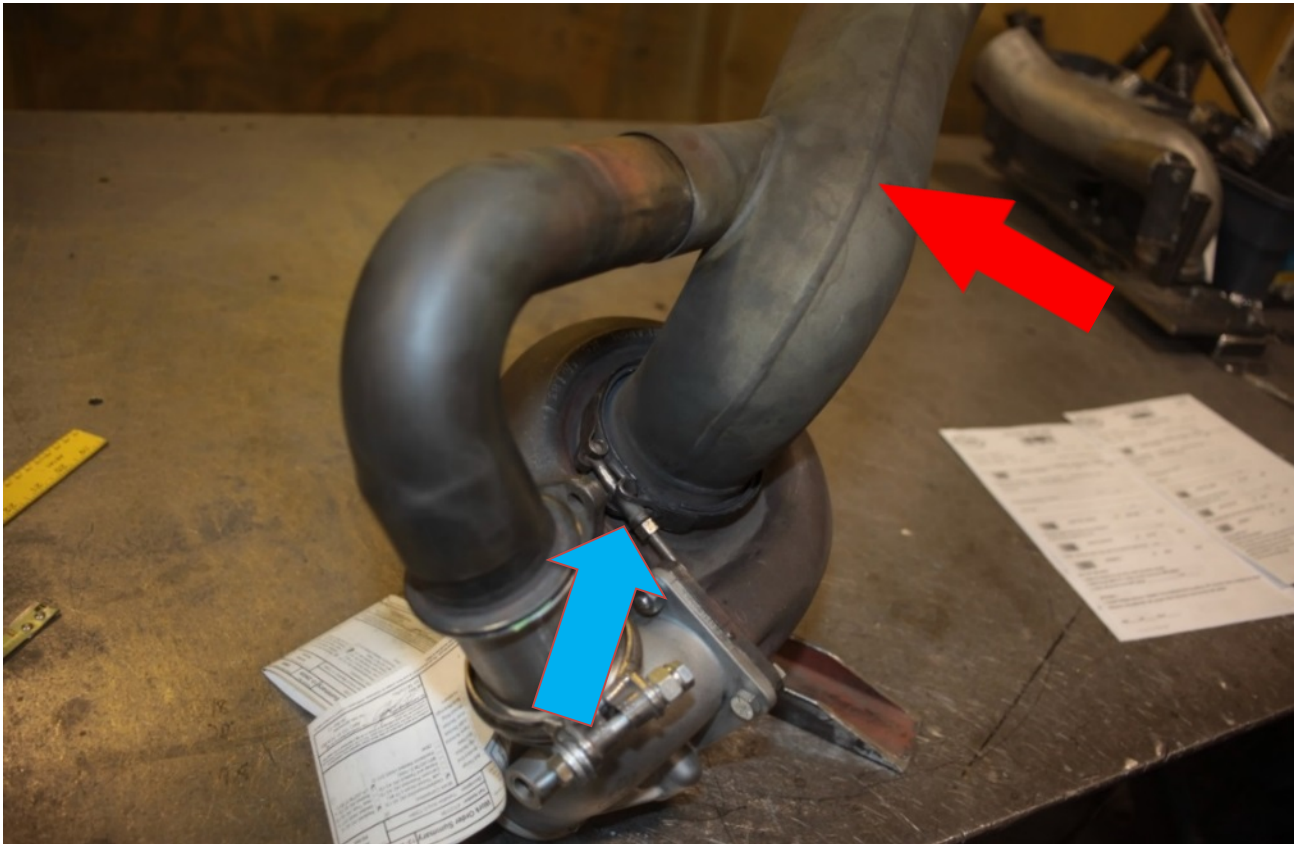
Another turbocharger assembly is depicted below (looking at the exhaust end on the bench). This version has the tailpipe (with a wastegate pipe and valve installed) installed on the turbocharger exhaust exit with a V-band coupling. The tailpipe is denoted by the upper red arrow and the multi-segment, V-band coupling is denoted by the lower blue arrow. Finally, even with the turbocharger assembly on the bench, a thorough inspection of the V-band coupling as installed is difficult. It is unlikely that one would be able to assess the interior of the coupling in hopes of finding a crack that lurks in a V-retainer inner radius on the coupling

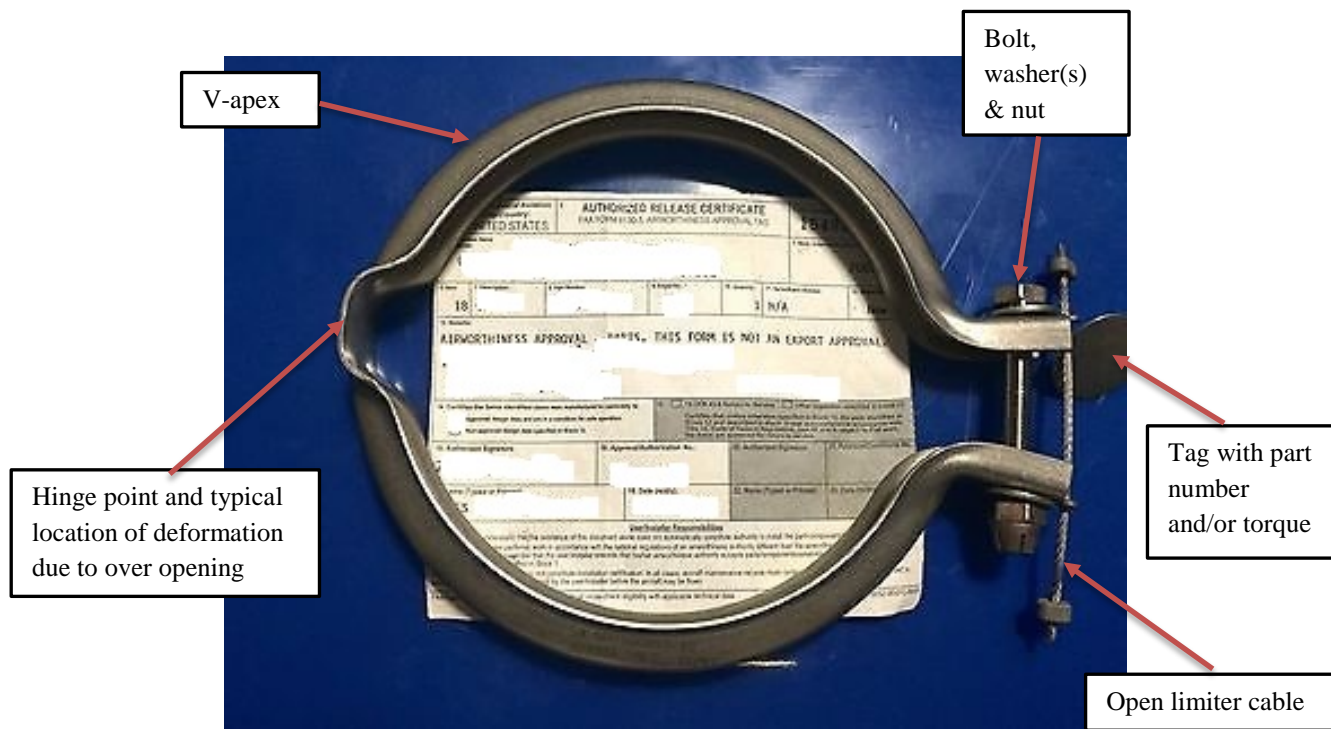
**Figure 7**

Single-Piece, V-band *Clamps* are stamped and roll formed from one single-piece of base material. Materials used throughout are various stainless steel alloys or Inconel's. The single-piece straight (only) bolt is a stainless steel alloy. The self-locking nut is typically a high temperature steel alloy that is often silver coated. The self-locking nut is all-metal and the locking feature is a mechanical interference type with no polymer inserts. There is typically one washer under the bolt head and one washer under the nut on these clamps. They also typically come with a cable across the open end which acts as an open limiter. Installed on that cable is a tag with torque and/or part number and a pair of crimped on sleeves to limit opening. Lack of the cable (if applicable to the p/n), torque tag and/or crimp(s) that appear replaced should make the clamp suspect. Refer to Figure 7 and 8.

**Single-Piece, V-band *Clamp***

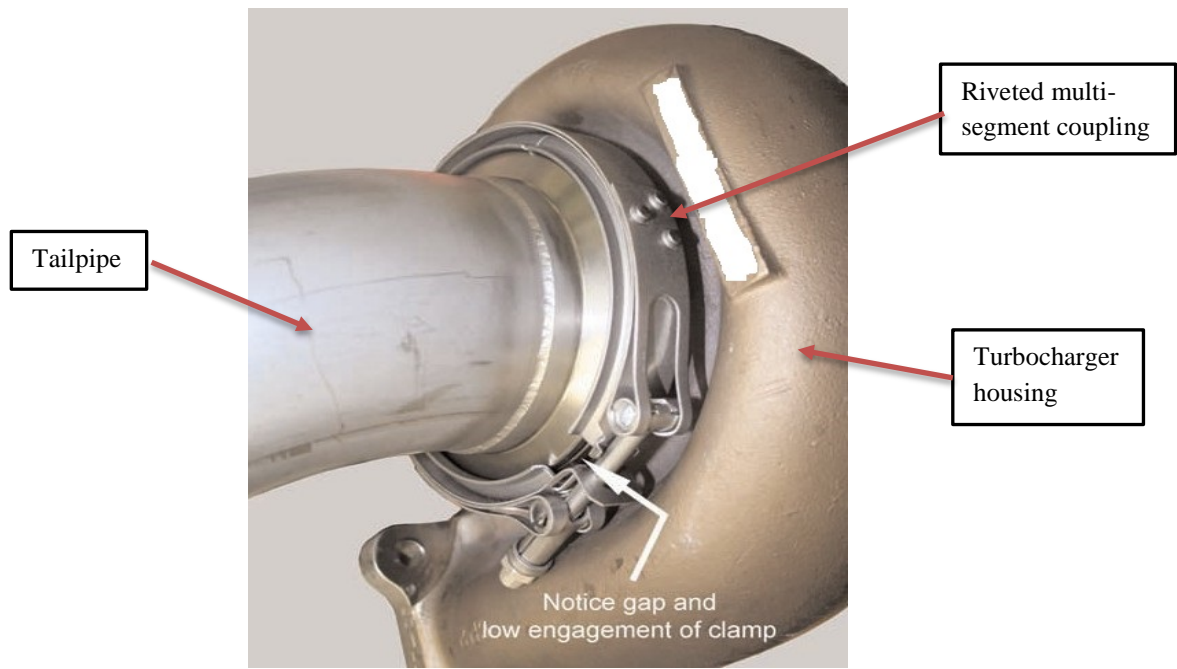
**Figure 10**  
**Typical installation of tailpipe and V-band coupling on turbocharger exhaust flange**

- e. Assemble the tailpipe exhaust flange on to the turbocharger exhaust flange, with a new gasket if applicable per the DAH type design configuration or current Instructions for Continued Airworthiness (ICA). Carefully twist the coupling/clamp over the flanges as if to follow the flanges as a nut would on a screw thread. Refer to Figure 10.
- f. Ensure alignment of tailpipe flange and turbo exhaust exit flange with no gaps (maximum 0.005 in.), prior to coupling/clamp installation. Refer to Figure 9 & 10.

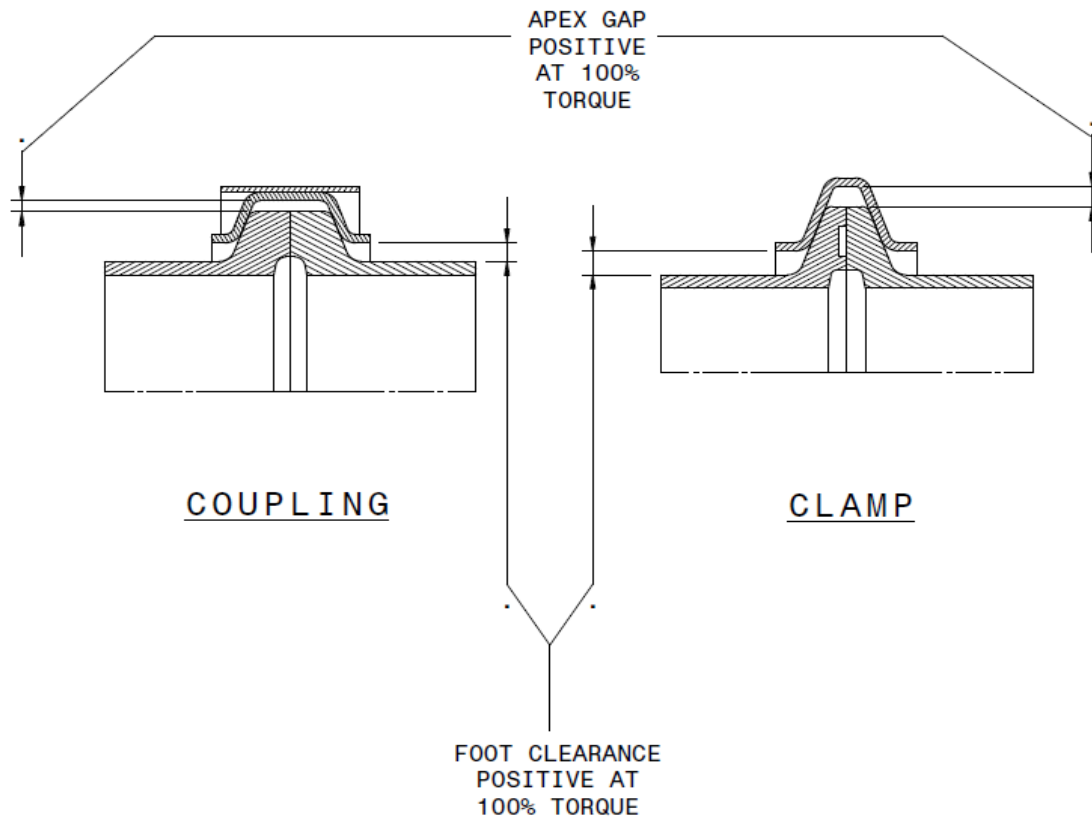
**Figure 11**  
**Coupling & Clamp Installation Clearances**

- k. Check the coupling V-retainer and clamp V-band apex gap and foot clearances. At full torque, a positive clearance must be maintained throughout to prevent the coupling/clamp from bottoming out on the flanges before the required loading has been achieved. Refer to Figure 11.

- j. Lack of positive clearance at either the apex gap or foot clearance locations at full torque. Refer to Figure 11.
- k. Bolt shank bent, bowed, or deformed (not at the T-bolt head end, as there are some which are manufactured with a slight angle to it.)

- o. After a coupling/clamp is installed/reinstalled and fully torqued, check the coupling V-retainer and clamp V-band apex gap and foot clearances. A positive clearance must be maintained throughout to prevent the coupling/clamp bottoming out on the flanges. If there is no clearance in either location, a new coupling/clamp should be installed prior to further flight. Refer to Figure 11.

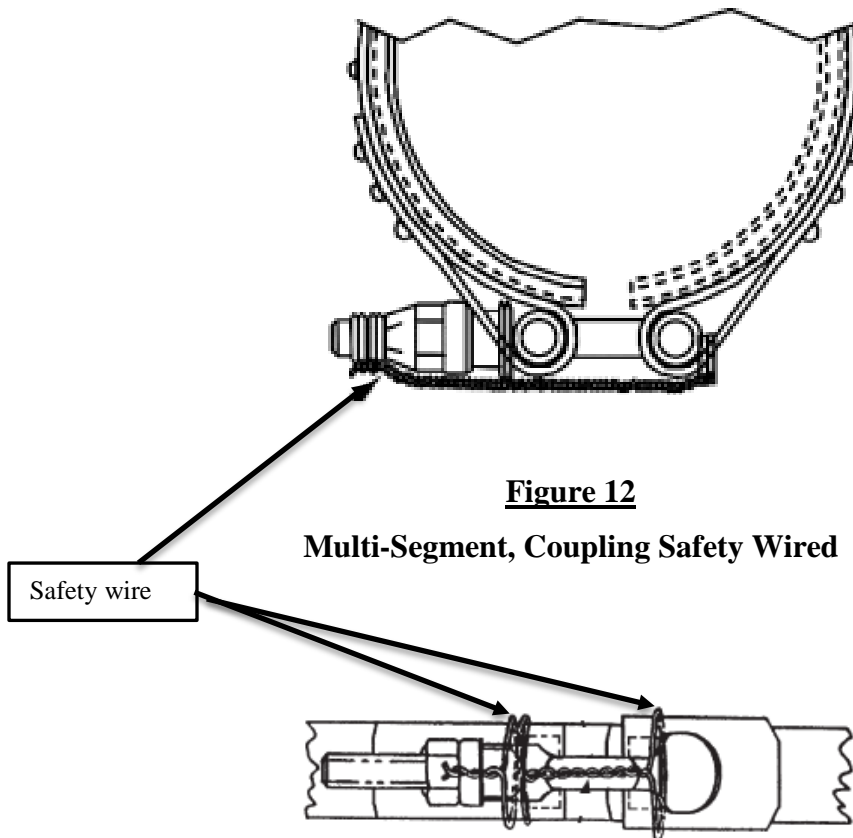
**Figure 12**

**Multi-Segment, Coupling Safety Wired**

- l. We recommend safety wire (minimum 0.032 in. stainless steel) per acceptable methods the bolt head to the nut end trunnion of the coupling as applicable to preclude opening of the coupling if the bolt or nut loosens, fails, or separates from the mating fastener after installation. Refer to Figures 12 & 13.

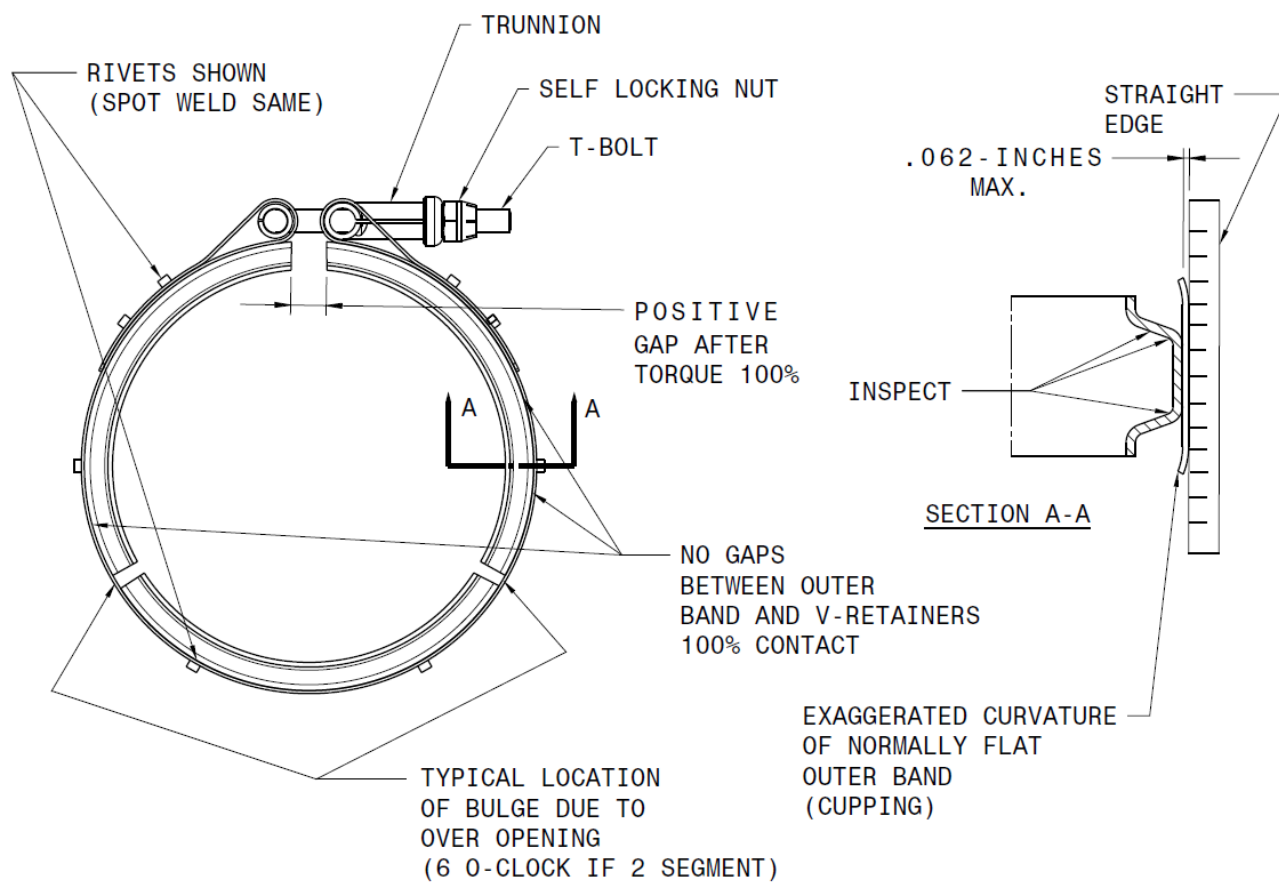
**Figure 14**  
**Multi-Segment, V-band Coupling**

- c. Visually inspect the coupling outer band for flatness using a straight edge. Lay the straight edge across the width of the outer band. The gap between the straight edge and the band must be less than 0.062 inches. Refer to Figure 14.

- h. Clamp part number and/or torque tag (if applicable to the specific part number of clamp) missing or detached. Refer to Figures 7, 8 & 16.
- i. Contact of the V-retainer segments ends or clamp ends at any location (e.g. bolt area). Refer to Figures 14 & 16.

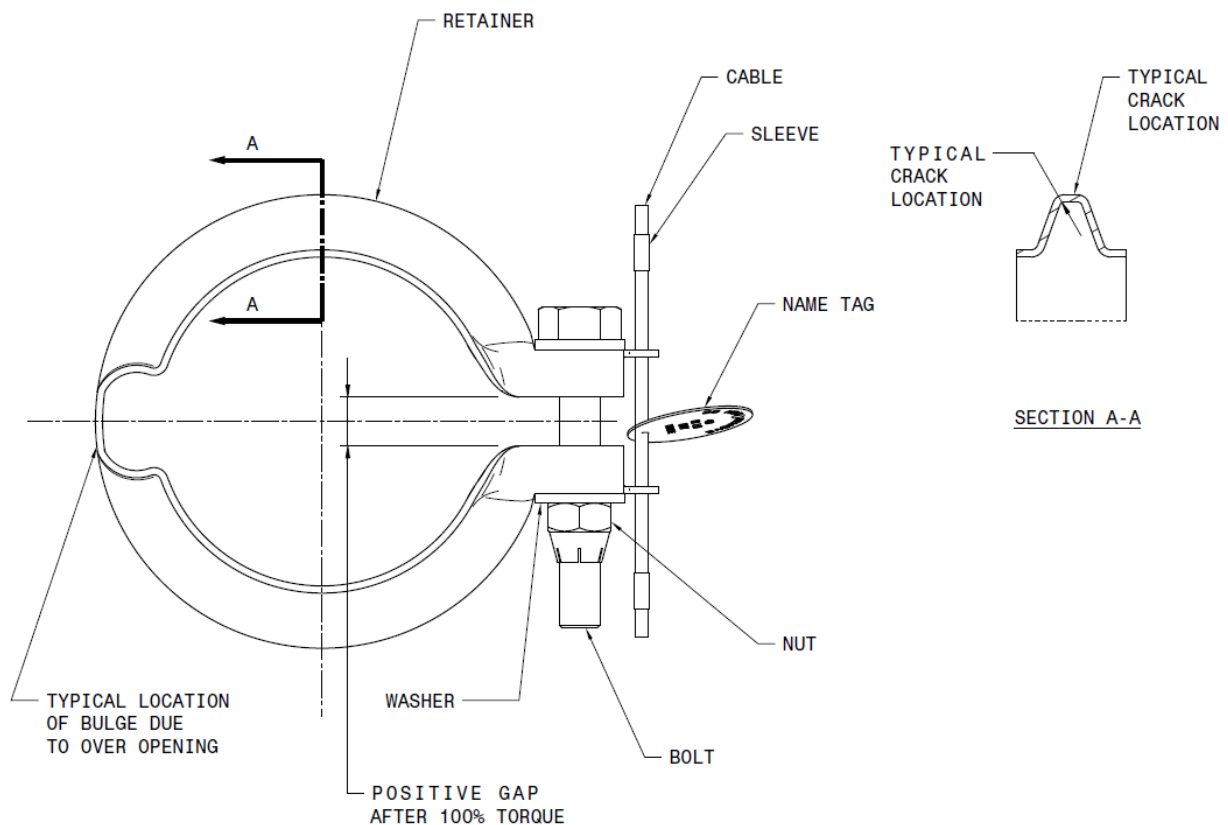
**Figure 16**  
**Single-Piece, V-band Clamp**

- f. Crack in the clamp V-band exterior or interior surface along the V-apex, around the perimeter. Refer to Figures 16, 26 & 27.
- g. Clamp open limiter cable (if applicable to the specific part number of clamp) missing or detached. Refer to Figures 7, 8 & 16.

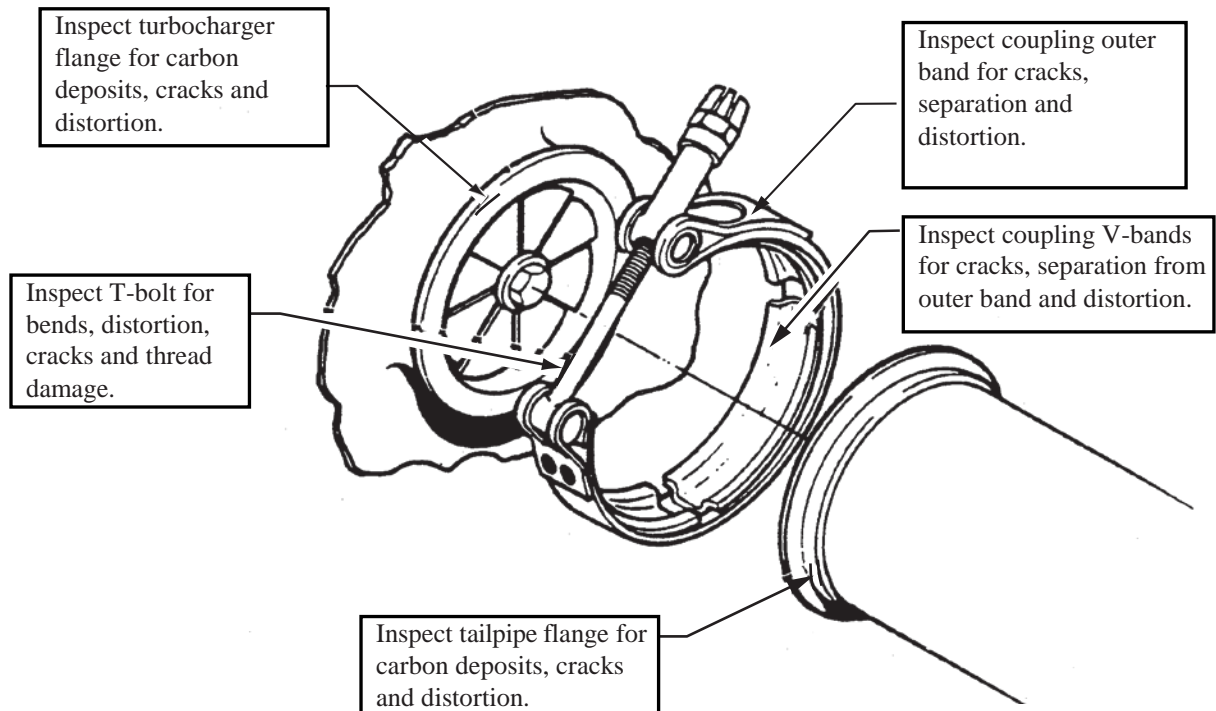
**Figure 17**  
**Typical Turbocharger to Tailpipe Interface Area**

- a. Hereafter, if required, clean engine exhaust components per acceptable or approved methods using acceptable or approved materials. Pay particular attention to the outer band (flat) of a multi-segment V-band coupling, specifically at or near any spot weld or rivet, and the outer surface of the V-band on a single-piece V-band clamp. Refer to Figures 4-6, 14-16, 19, 21-23, 26 & 27.
- b. Use a 10X magnifier and bright lighting, backlighting may also be useful. Refer to Figures 14-17, 19, 21-23 & 25-27. Pay particular attention to the spot-welds or riveted areas on multi-segment couplings and the outer surface of the V-band on single-piece V-band clamps and areas that are initially hard to get to or see as installed, as these may have been neglected in prior inspections and may harbor problems.

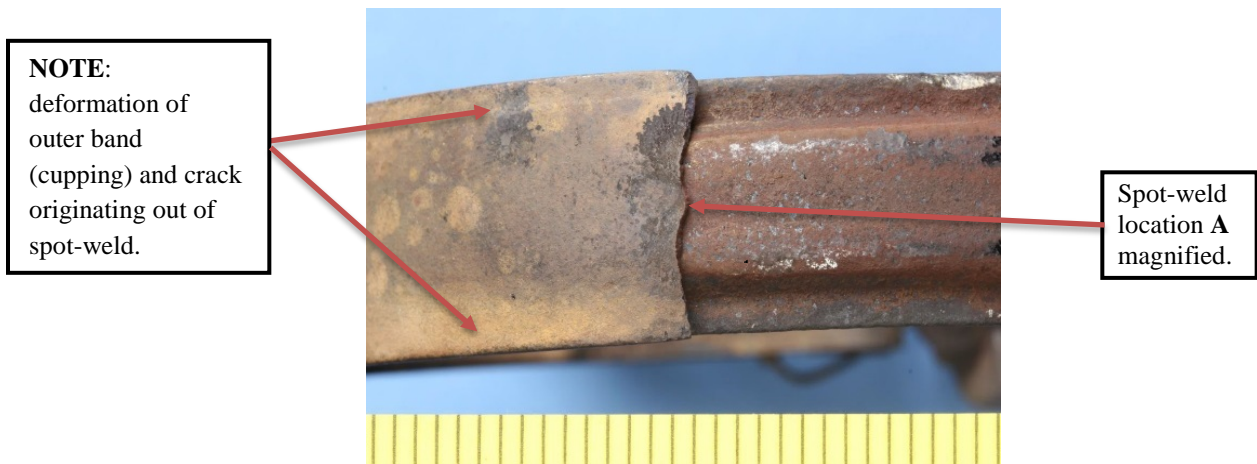
**Figure 19**

**Spot-welded, 2-segment Coupling with Quick Release Latch**

**Same coupling above magnified**
